1.2 DESCRIPTION AND GAZETTEER

1.2.1 Visible and buried remains of Merton Priory

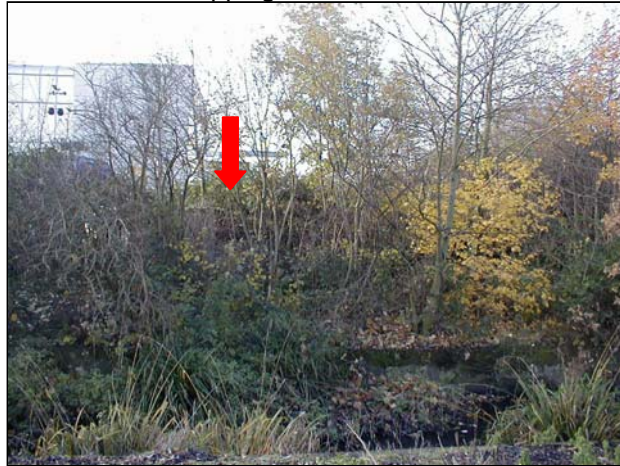
From a to b it appears to be about two metres high and constructed of flint, stone and brick with a brick capping.

The monastic precinct wall,
Section a-b (arrowed), looking
west across The Pickle.

It is difficult to be precise about the extent and condition of the wall, but it is clearly an important surviving element of the Priory and should, ideally, be cleared of vegetation and repaired for display.

- built in medieval period as monastic precinct wall but evidently altered and repaired;
- appears to be a relatively good condition, but closer inspection desirable
- a significant and surviving element of the Priory;
- Grade II Listed building;
- need for vegetation clearance, repair and display.

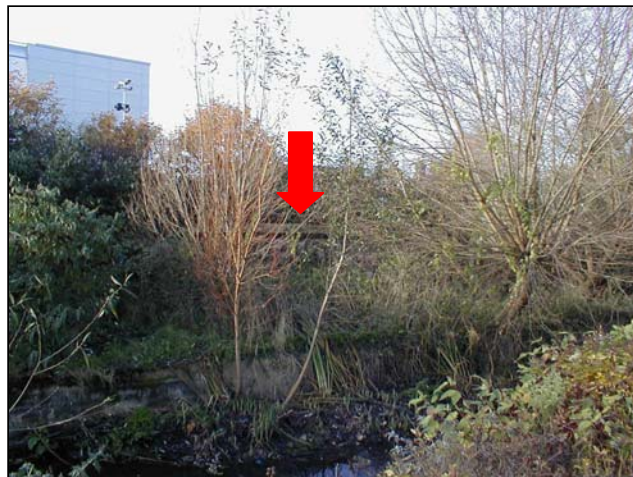
The monastic precinct wall,
Section c-d (arrowed), looking
west across The Pickle.

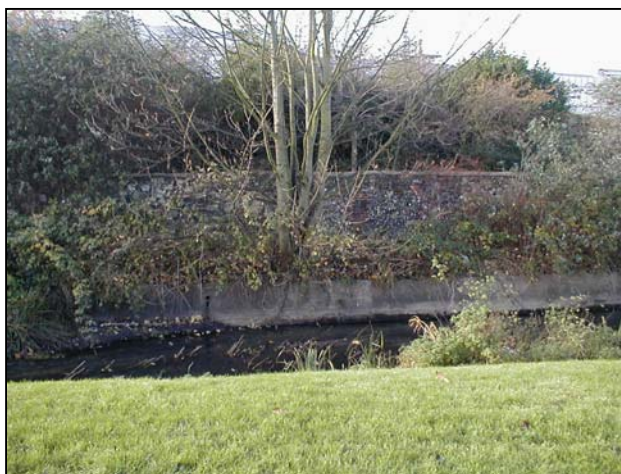
From e to f the wall runs close to The Pickle and is more clearly visible, about two metres high, in a form similar to the other surviving sections.

The monastic precinct wall, Section e-f, looking west across The Pickle.

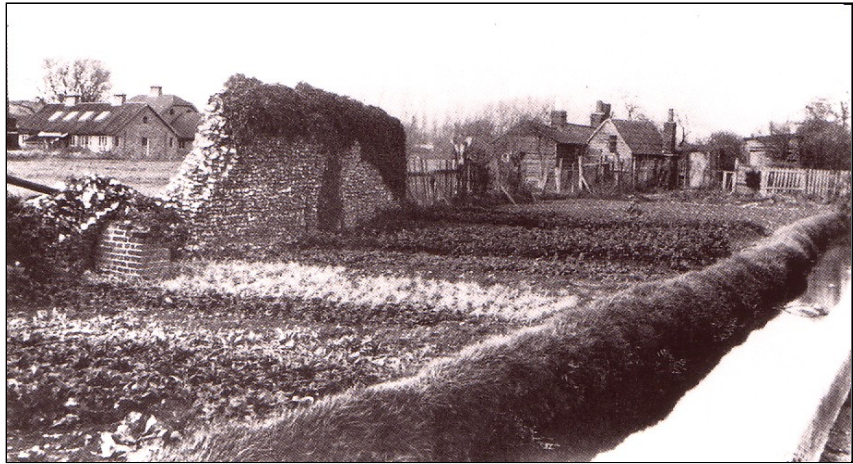
It is probably part of this wall that appears in the photograph taken in the early twentieth century, with part of the Merton Abbey Works in the background to the left and buildings on Phipps Bridge Road to the right.

An early twentieth century photograph recording part of the precinct wall which existed at that time, probably near Phipps Bridge Road (after Bruce and Mason 1993 : 7)).

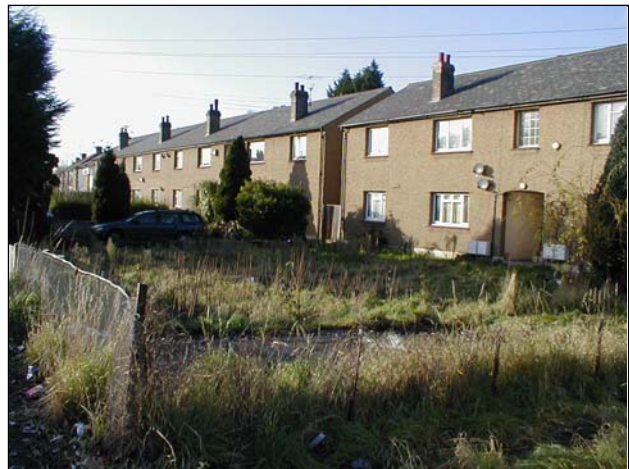
At that time the land was open fields, but the area was developed for housing in the 1930s. At that time the stream appears to have been, for the most part, taken underground and its course, and probably that also of the wall, is probably in a band of undeveloped land in front of the houses.

Houses near the north end of Liberty Avenue, showing the site of the precinct wall and stream in the foreground.

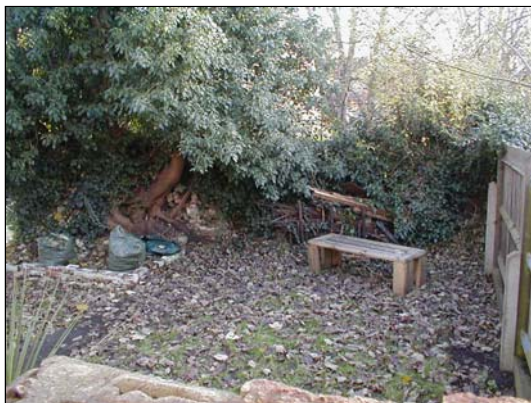
The precinct wall is preserved here in two small sections. In the garden of Nos. 15/17 Windsor Avenue there is a small and very overgrown fragment of masonry, with a large tree growing from it.

Fragment of wall at 15/17 Windsor Avenue, looking south.

- built in medieval period as monastic precinct wall;
- in very fragmentary condition;
- a significant and surviving element of the Priory;
- no statutory protection;
- need for vegetation clearance, repair and display.

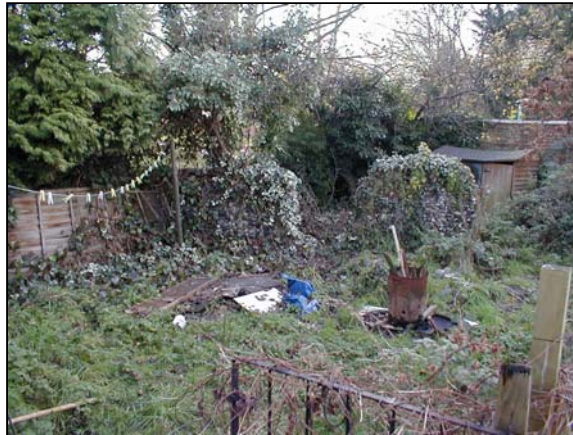
In the gardens of Nos. 27/29 and 31/33 Windsor Avenue the wall appears to survive in marginally better condition though it is collapsed and overgrown.

Fragment of wall at 31/33 Windsor Avenue, looking south.

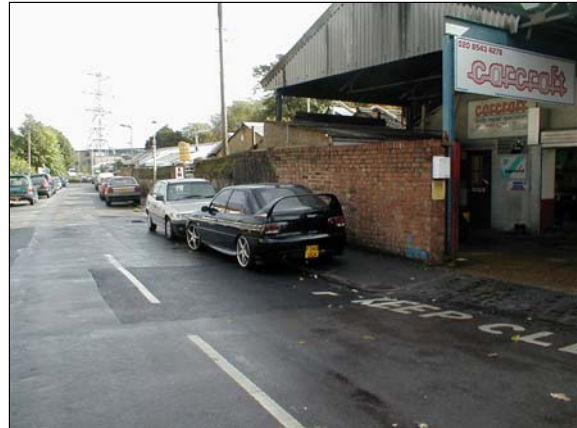
At the time that the Conservation Plan was being prepared in December and January 2005/2006 parts of the wall were being repaired. The surviving sections have clearly been much repaired in the past and it is difficult to know how much original, i.e. medieval, fabric may survive.

The first part of the wall (a-b), looking east along Station Road.

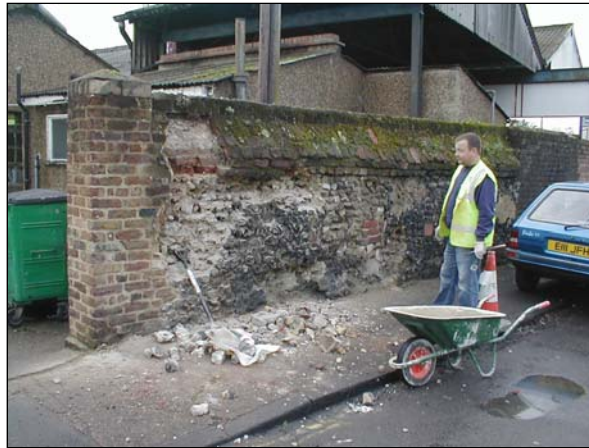
After this there is a section of wall, about 6 metres in length and about 2 metres in height, which is of flint with a substantial brick coping, possibly of seventeenth or eighteenth century date

Part of the first part of the wall (a-b).

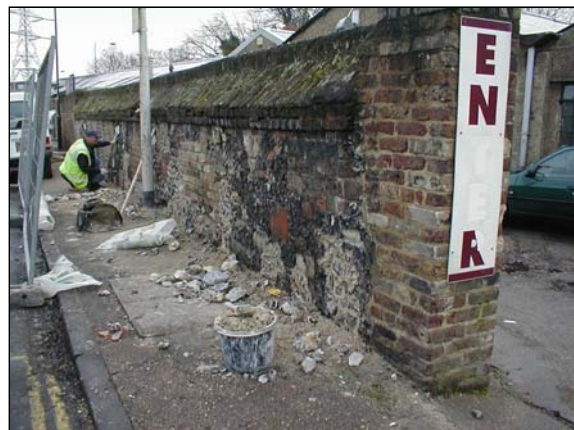
This is followed by another section of wall, about 15 metres in length, of flint with a substantial brick coping in the same style as the previous piece (b-c).

The lay precinct wall (d-e), looking east along Station Road.

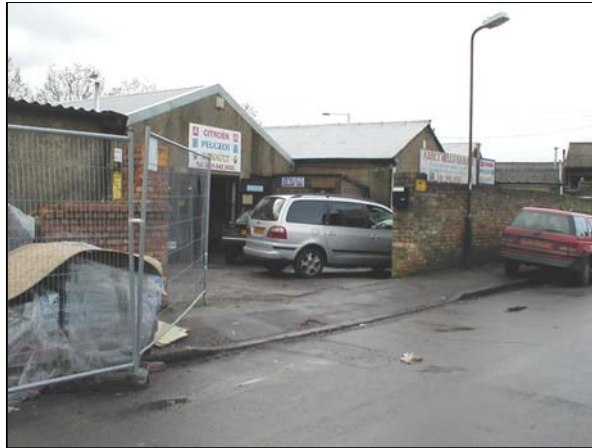
There is then a length of relatively modern brick wall, about 8 metres in length and 2 metres high, on the line of the original, followed by a gap about 5 metres wide.

Recent wall and gap on the lay precinct wall (e-g), looking west along Station Road

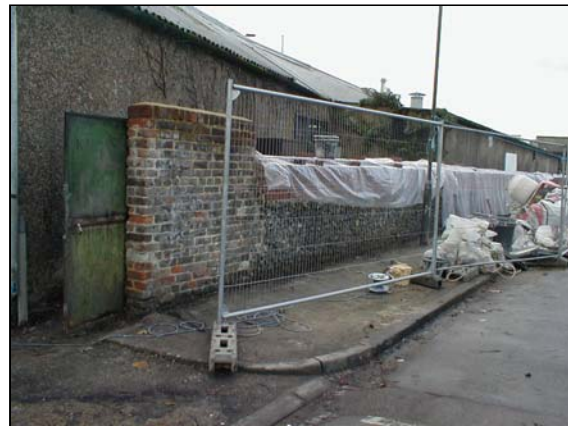
After the gap there is a length of flint wall, about 34 metres in length and 1.4 metres high, which has been capped on top with new brickwork as part of the recent repairs.

The lay precinct wall (g-h), looking west along Station Road.

- possibly on the alignment of and retaining some original fabric from the medieval lay precinct wall, but much rebuilt and repaired since then;
- currently being repaired after which it will be in condition;
- a significant element of the medieval Priory;
- Grade II Listed building;
- no management issues identified.

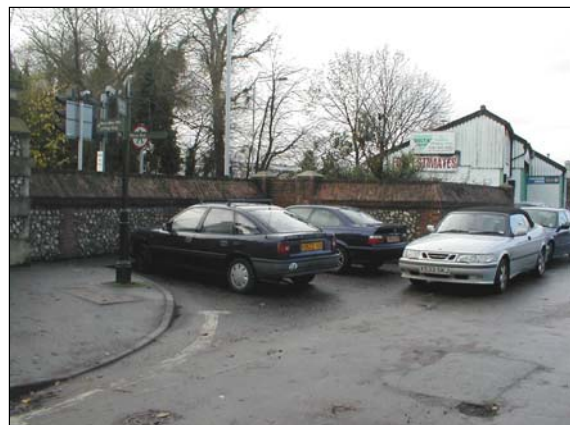
There is then another gap (h-j) followed by three short sections of wall, each about 6 metres, 5 metres and 7 metres in length and about 1.4 metres high, in the form of a dog leg. Built into the dog leg was an opening with brick piers, but this has been blocked. The flint and brickwork here appears to be of much more recent origin and possibly dates to the last 30 years.

The outer court wall (j-k), looking west along Station Road.

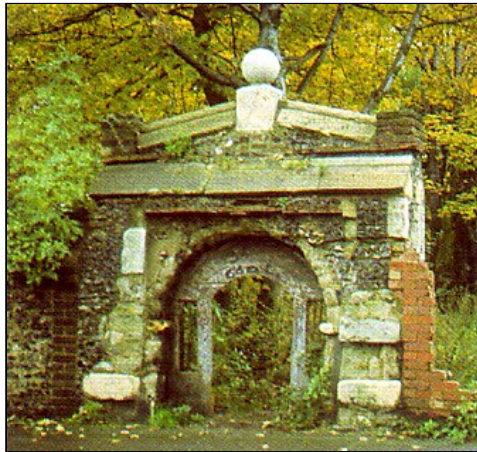
This is the gateway adjoining Station Road which appears on all editions of the Ordnance Survey twenty five-inch plan, commencing in 1871. The original gateway was demolished in the 1980s and replaced by a replica on the same site, which gives pedestrian access through the wall from Station Road onto Merantun Way.

The original gateway prior to demolition, probably looking south across Station Road.

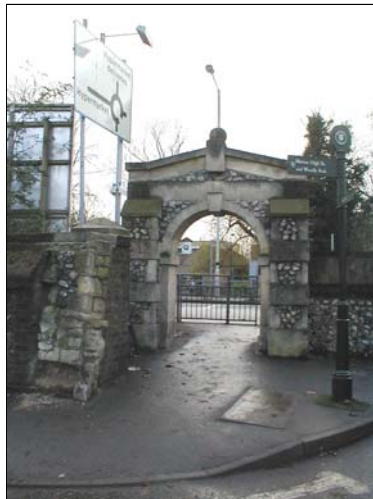
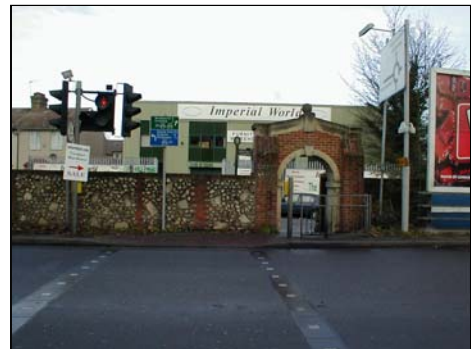
The modern replacement, looking south from Station Road (left) and looking north (above).

The date of original structure, which must have been of some historic and architectural significance, has been discussed above. The modern replacement, which does not closely resemble the original nor does it contain any re-used material, is of little interest. To the immediate east of the gate, and forming a return on the outer court wall, is what appears to be part of an older stone-built buttress.

- 1980s replacement of a medieval and later structure;
- the present structure is in sound condition;
- of significance in that the gateway may preserve the position of an original entrance into the lay precinct;
- Grade II Listed building;
- no management issues identified

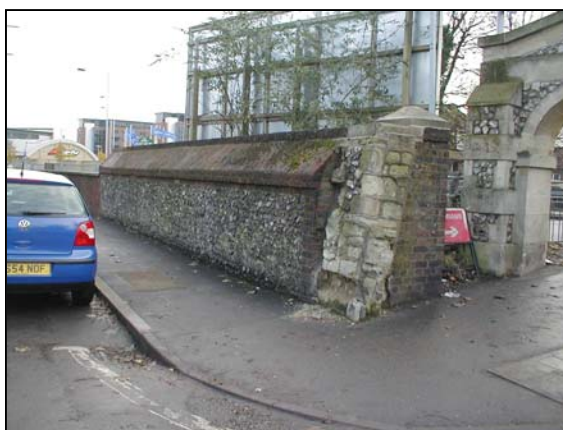
To the east of the gateway there is another section of flint wall with large brick coping, about 10 metres long and 1.4 metres high, which has either been heavily restored or is a later replacement of the original precinct wall.

*The outer court wall (k-l),
looking east along Station
Road.*

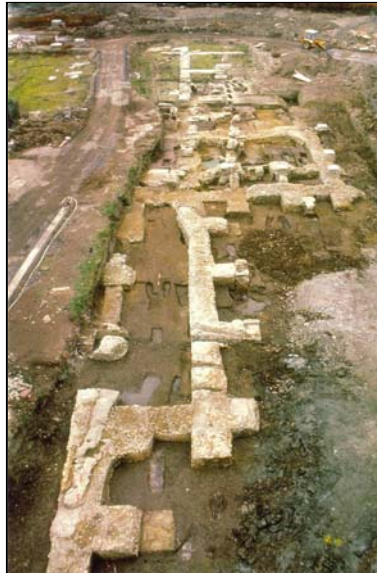
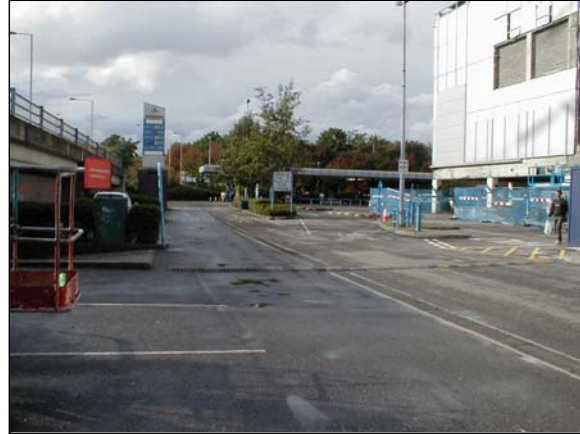
The excavations demonstrated that the walls of the Priory church had been demolished to ground level either at the Dissolution or shortly afterwards. In some cases even the foundations had been robbed.

The excavations of the north side of the Priory Church (after Saxby 2005 : 9) and a view of approximately the same area today.

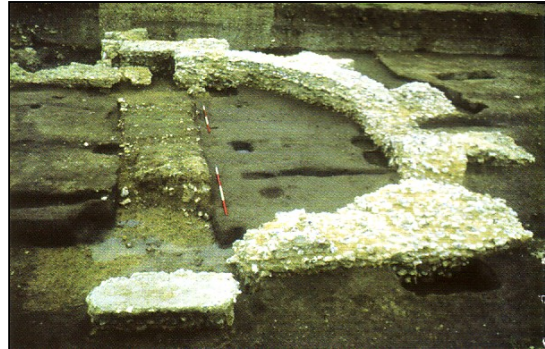
It was partially excavated by Bidder and Westlake in 1921-1922 and then fully excavated by the Museum of London between 1986 and 1990, at which time the two phases of construction were revealed, along with 31 burials internally within the building.

The east end of the chapter house, during excavations (after Saxby 2005 : 12).

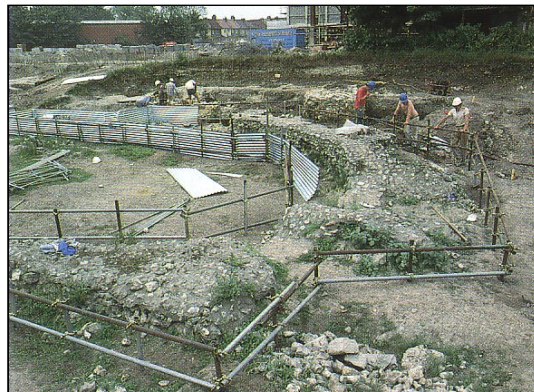
When the new Merton relief road, to be known as Merantun Way, was built the remains of the chapter house were protected and a purpose-built cover chamber was created around and over the surviving structure beneath the road, which was built at a raised level (see below Section 1.2.3 - 301).

The remains of the chapter house, immediately prior to the construction of the cover building (after Bruce and Mason 1993 : 15).

- built in the thirteenth century and extended in the fourteenth. Demolished at and after the Dissolution in 1538;
- survives as footings within a covered building;
- a very significant element of the Priory;
- contained within the Scheduled Ancient Monument;
- in need of repair

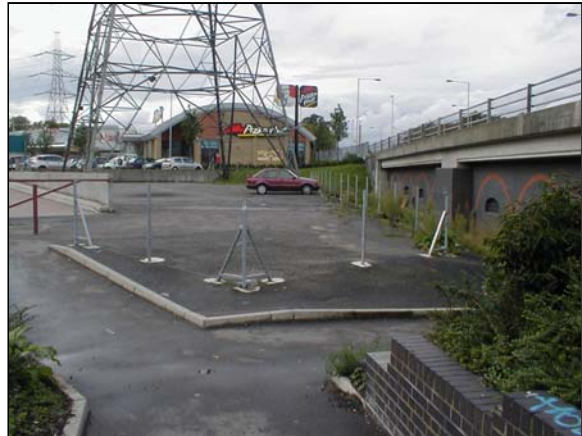
The base of the electricity pylon and site of the south range.

It is understood that test pits were excavated here prior to the erection of the pylon and that the ground level has been raised to protect any buried features which may survive.

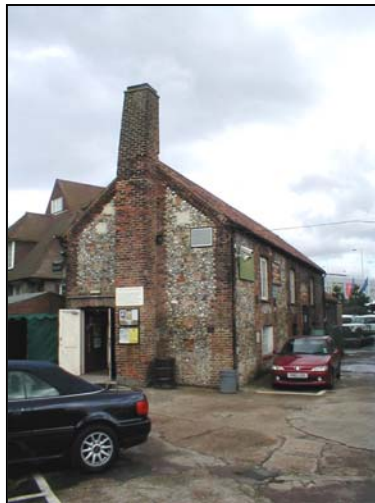
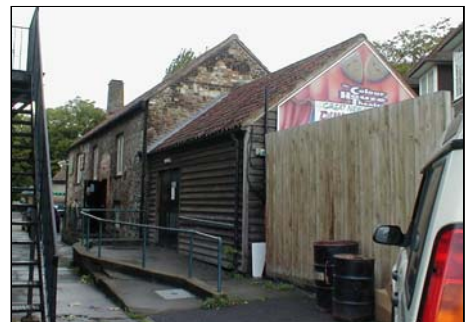
Colour house of textile printing works. Dated 1742 with late C19 alterations. Brick and flint with random rubblestone blocks (reused stone); brick quoins. Pantiled roof pitched to eaves. Two storeys. Segmental headed windows. Brick surrounds.

The Colour House, from the south (left) and the east (above).

The building is as described in the Listing description and now has a timber extension at the east end.

- built in 1742;
- complete and appears to be in good condition;
- a very significant industrial building, erected to serve the first calico-printing works on the site, and claimed to be the oldest industrial building in London;
- Grade II Listed building and in Designated Conservation Area;
- no particular management issues identified.

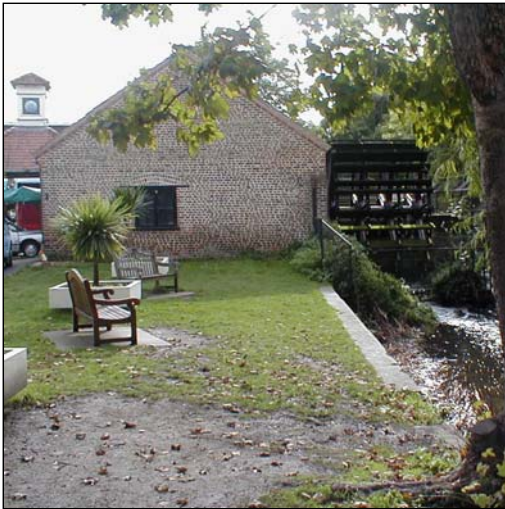
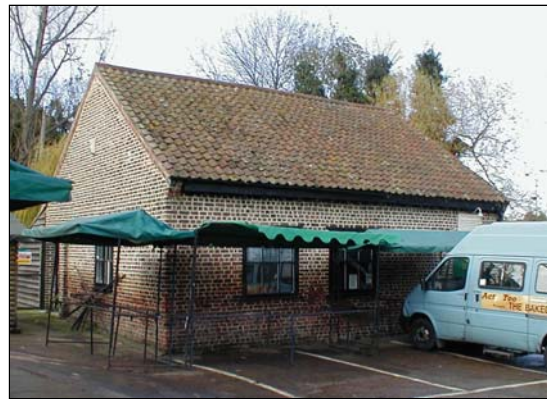
Wheel house to textile printing mill. C18. Brown brick. Pantile roof, low pitched to eaves. Gable end to road; CI9 undershot wheel exposed to right with four sets of seven cast iron arms. Messrs Liberty's Print works stands on part of site of Merton Priory. The site has been used for printing textiles for the past two centuries. The wheel house was used for washing materials in the Wandle during part of the processing.

*The wheelhouse, from the north (left)
and from the south-east (above).*

The building is as described in the Listing description. The unique 7-spoke waterwheel and wheelhouse is believed to date from circa 1860 and is claimed to be London's only working example.

- built in the early eighteenth century and accommodating a waterwheel of circa 1860;
- complete and appears to be in good condition;
- a very significant industrial building, erected to provide power for the first calico-printing works on the site;
- Grade II Listed building and in Designated Conservation Area;
- no particular management issues identified.

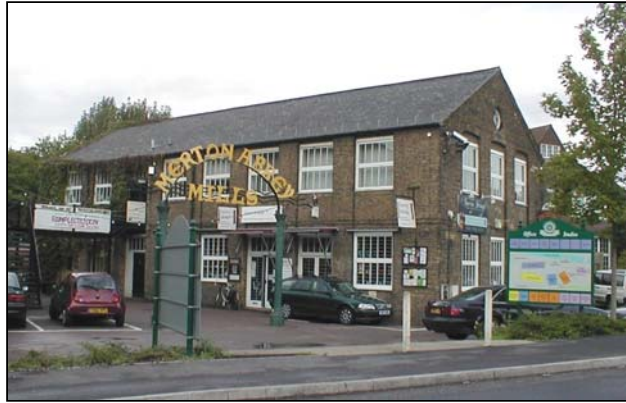
The building is of two-storeys, of yellow brick under a gabled roof of slates, and of eight bays.

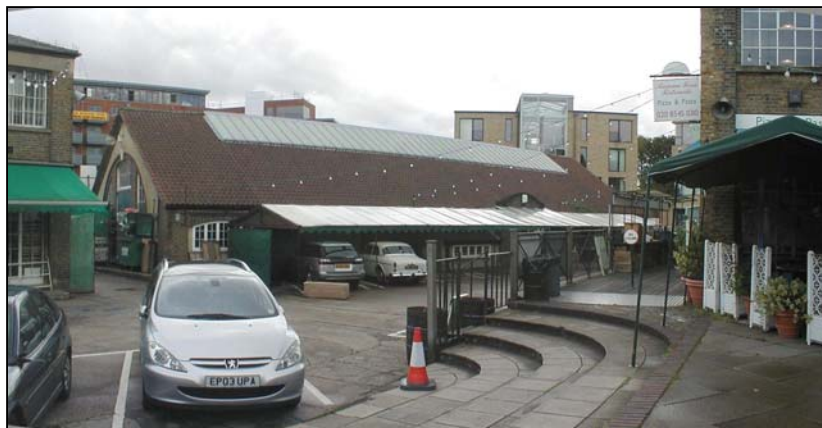
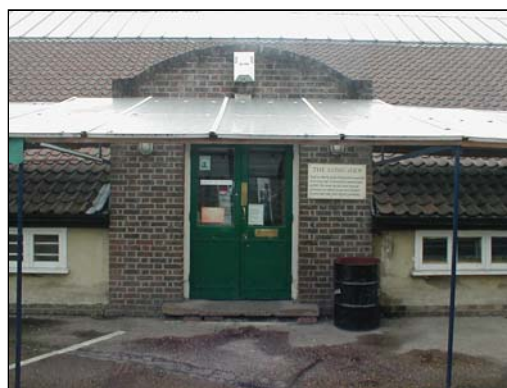
The Long Shop, from the north-west (above) and a detail of the entrance on the west side (right).

It is a single-storey structure of brick, some rendered, under a pitched roof of pantiles, containing roof lights close to the ridge and supported on steel trusses.

It is used as part of the Merton Abbey Mills market and appears to be in sound condition.

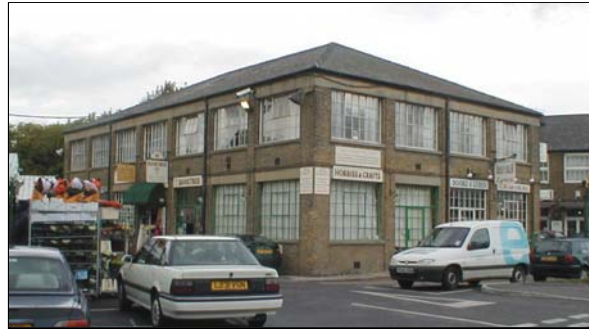
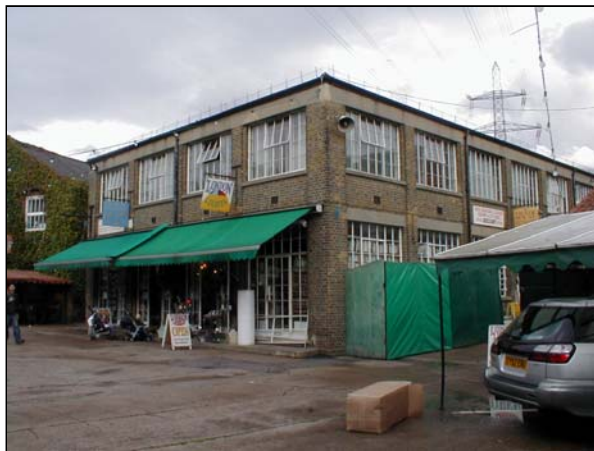
The Apprentice, from the south-east (right) and from the south-west (below).

It is two-storeys high and of yellow brick, under a hipped roof of slates. It is rectangular in plan of five bays by four.

It was restored in 1989 and is currently used as craft shops and studio offices.

- built in 1926 for Liberty's silk printing works;
- complete and appears to be in good condition;
- a significant industrial building;
- in Designated Conservation Area;
- no particular management issues identified.

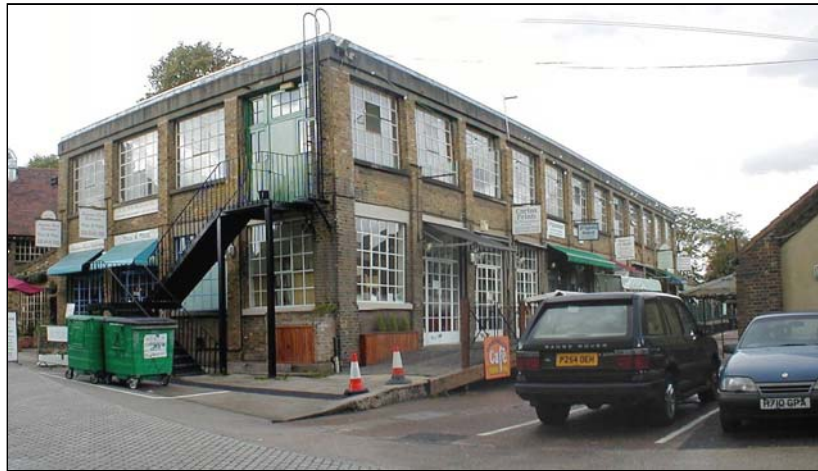
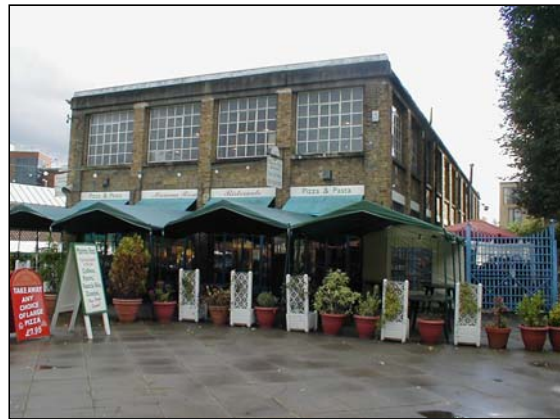
The 1929 Shop, from the south-east (above) and from the north (right).

It is two storeys high and of yellow brick under a flat roof.

It was restored in 1989 and is currently used as craft shops, studio offices and a restaurant. It appears to be in good condition.

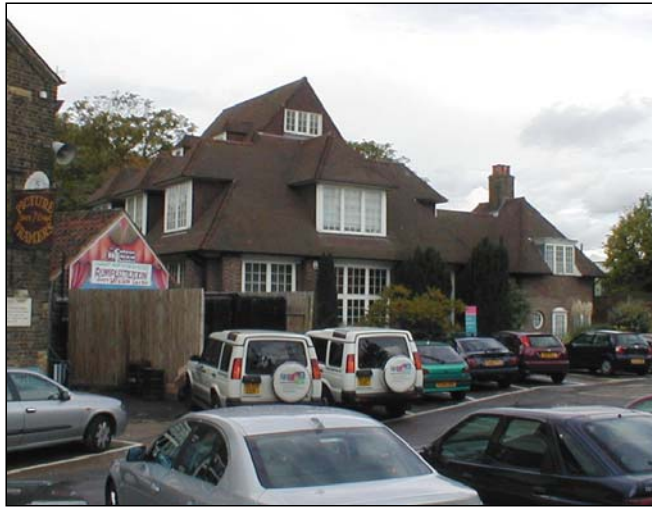
It is in the form of a chalet-style bungalow, with an extension to the north. It is of red brick under a tiled roof.

It appears to be in good condition.

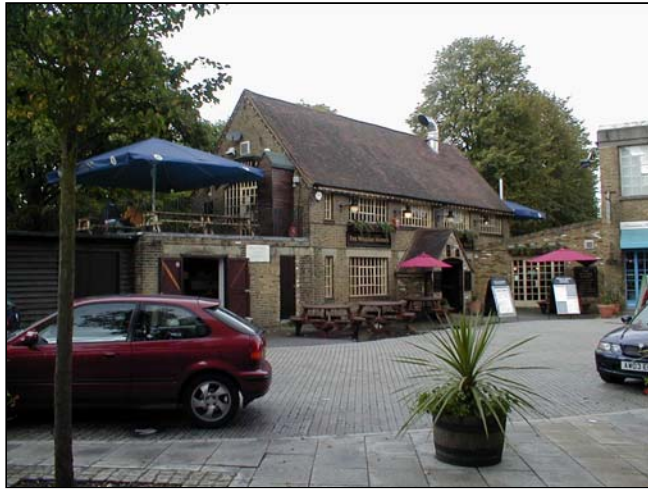
It is of two storeys of yellow brick under a tiled roof, and has been altered for its present use, which is as the William Morris public house.

The Block Shop, now the William Morris public house, from the south-east.

It appears to be in good condition, though much altered.

- built in *circa* 1930 for Liberty's silk printing works;
- much altered but in good condition;
- a significant industrial building;
- in Designated Conservation Area;
- no particular management issues identified.

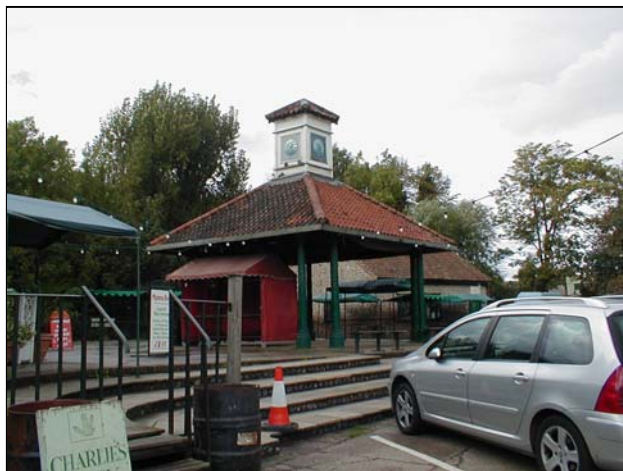
A cast-iron or steel structure, apparently dating from 1988/90, under a pyramidal roof of pantiles surmounted by a clock turret. Known as the bandstand.

The bandstand, from the south-east.

It appears to be in good condition.

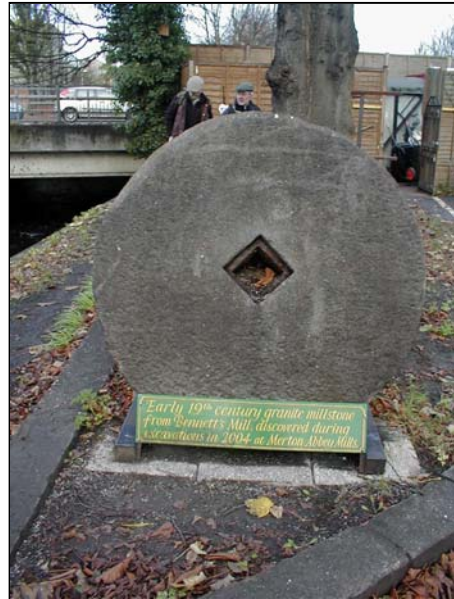
An early nineteenth century granite millstone, currently lying west of the Showhouse (see 207), was found in 2004 during excavations and is believed to have come from Bennett's Mill (see above Section 1.1.5).

The millstone from Bennett's Mill.

- early nineteenth century granite millstone ;
- not *in situ* but in good condition;
- a significant element from an industrial building;
- in Designated Conservation Area;
- no particular management issues identified.

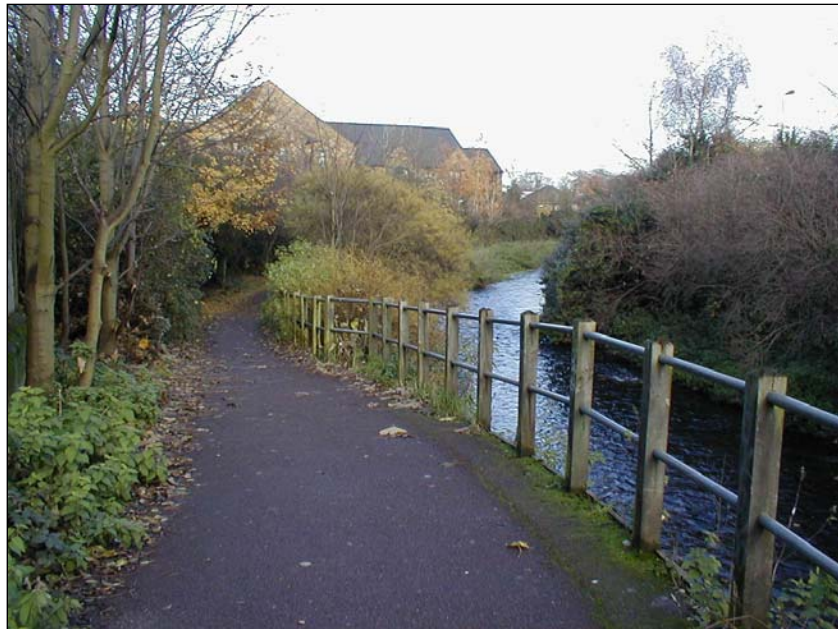
The footpath alongside The Wandle and the plaque marking the site of the William Morris works.

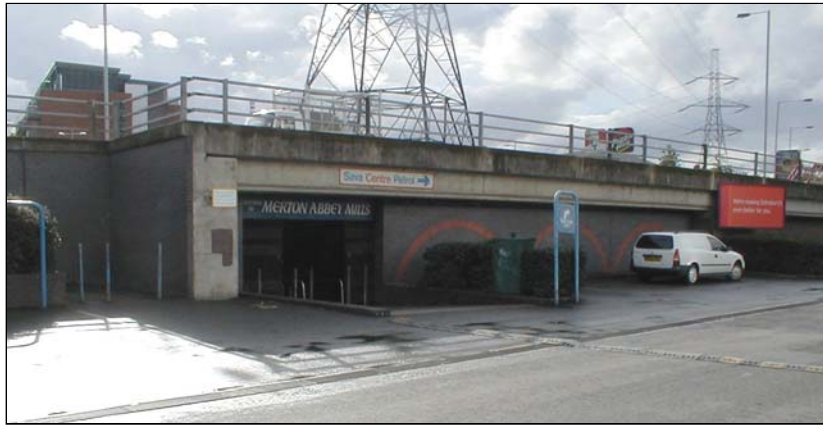
The north side of the Chapter House cover chamber, with the pedestrian underpass to the left (above); the visitor centre looking north through the underpass (below); and the south side of the cover chamber, with the underpass to the right (bottom).

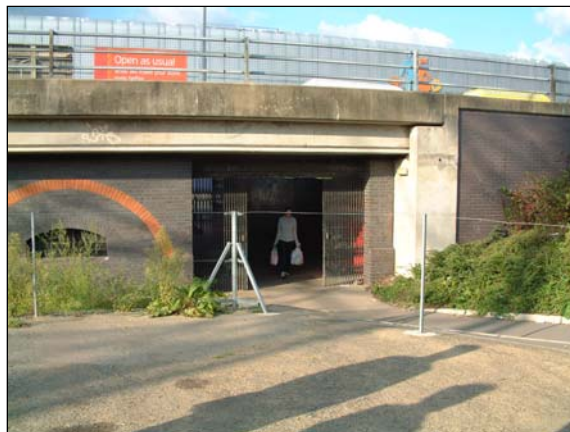
The entrance to the Chapter House cover chamber, looking north-east.

To compound matters, the site of the Chapter House is now located beneath the elevated A24 Merantun Way, which now bypasses Merton High Street, whilst the site is also beneath a high voltage overhead power line, supported by an adjoining pylon.

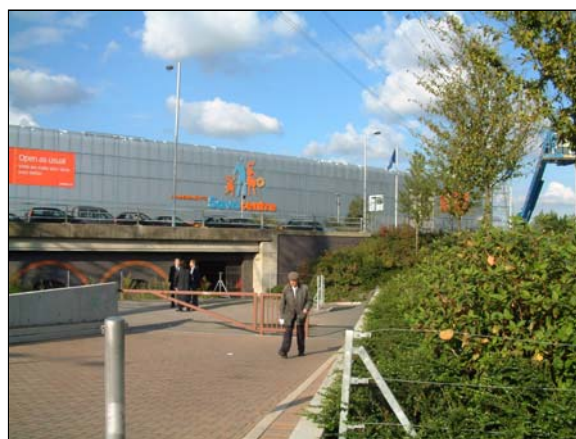
The approach to the Chapter House cover chamber, looking north-east.
